SAFETY INFORMATION

T.S.E. ONE PIN TEAR DROP CONTAINERS RESERVE PREMATURE DEPLOYMENT

SERVICE BULLETIN

TEAR DROP 1 PIN CONTAINER

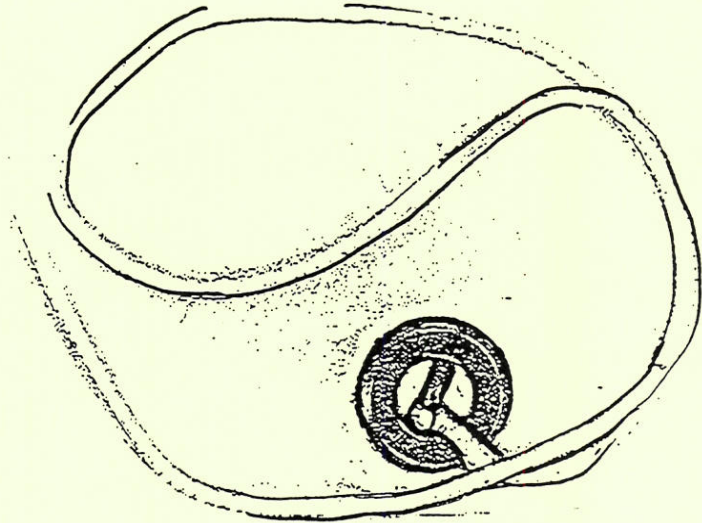
THE CYPRES TYPE OF LOOP.

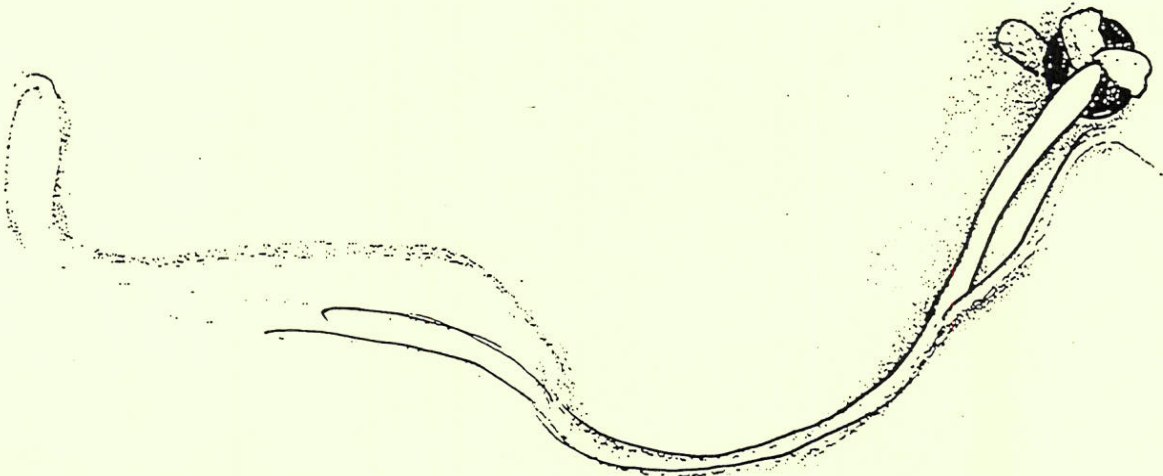
ON INSPECTION OF OLDER TEAR DROP 1 PIN WITH THE SMALL WASHERS ON THE RESERVE LOOP. IT HAS COME TO OUR ATTENTION THAT EXCESS WEAR WAS OCCURING AROUND THE SMALL WASHERS. IT WAS THEREFORE DECIDED TO CHANGE THESE LOOPS FOR THE CYPRES TYPE.

THE OLD TYPE OF LOOP WITH THE SMALL WASHER

Containers with the "old type" washers and loops should be changed to the updated type.
