Riggers' Subcommittee

Minutes of the meeting held on

Thursday 9 June 2022 at 1600

Urgent Safety Advice – Sports Parachuting Spring Activated Reserve Parachute Systems

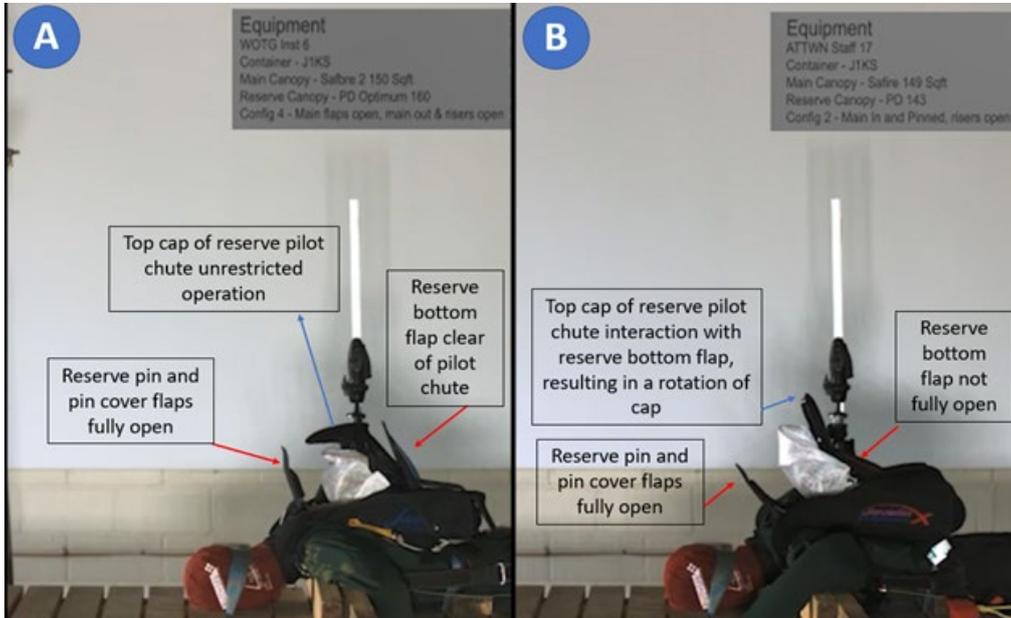
Figure 1 - WOTG SI Trial - Top cap and bottom flap interaction

Figure 1 below shows the initial interaction between the reserve bottom flap and the reserve pilot chute top cap. Container A, with the main canopy removed, allows full rotation of the reserve bottom flap, with the lower part of the flap assembly entering the empty cavity. Clearance with the top cap and pilot chute is maintained whilst they are being ejected. Container B has the main canopy still in the container, preventing the reserve bottom flap from fully rotating, which then interacts with the reserve pilot chute top cap, causing it to rotate.

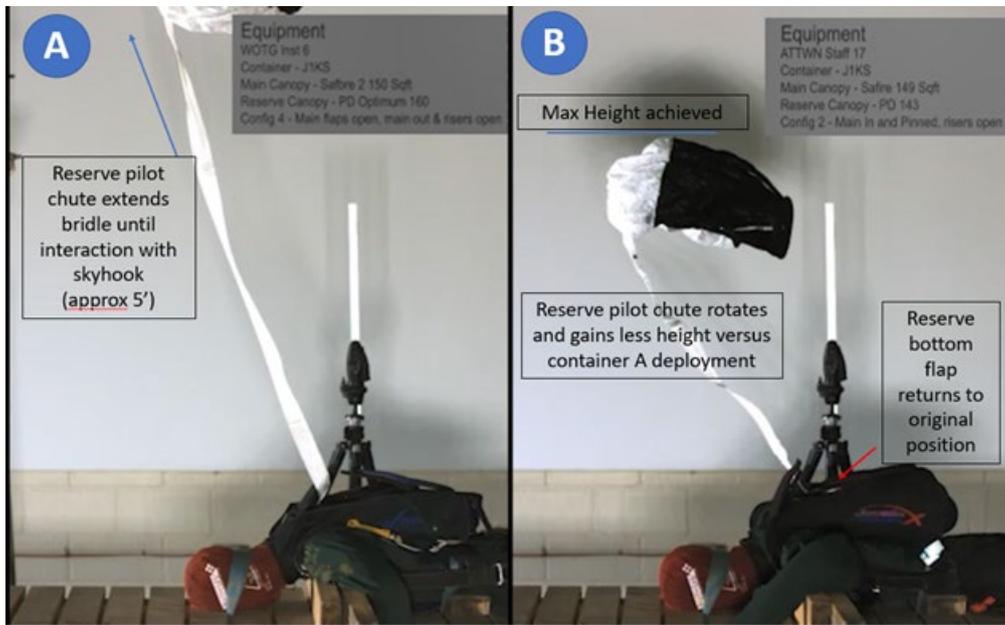
Figure 3 - WOTG SI Trial - Max height achieved

Figure 3 shows a successful deployment of the reserve pilot chute in container A. Container B demonstrates the result of the interaction with the reserve bottom flap, with less observed height gain and rotation of the spring and pilot chute.

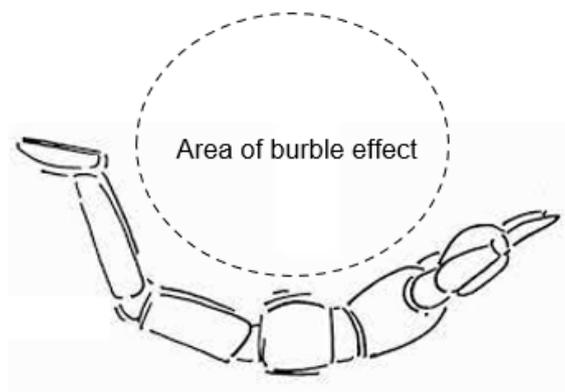
Figure 4 - Burble Effect

5. The chaotic airflow directly above a parachutist is commonly known as burble, as indicated at Figure 4 below. The exact size of this burble depends on many factors but it is attributed to the surface area presented to the relative airflow as the parachutist descends. Changes in body position or the use of ancillaries³ will change the shape and size of this burble; this should be considered and, if possible, mitigated against, particularly during emergency drills. The overarching factor is the total surface area presented to the airflow. As an example, a large-framed person or an individual wearing a loose fitting jump suit could produce the same size burble as a person who is much smaller wearing a camera jacket or using other ancillaries.
