SAFETY INFORMATION

04/25

Static Line Strong Point Incident

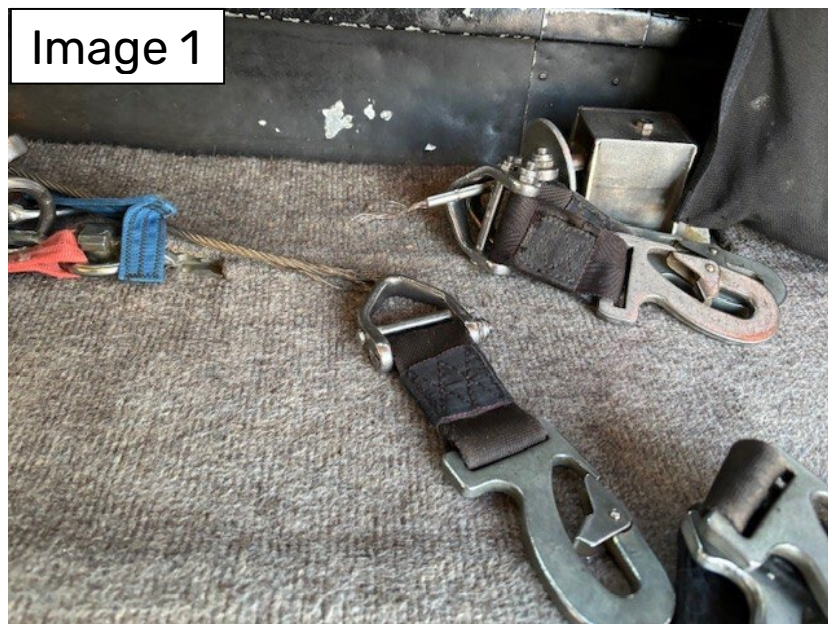
Immediately after the exit, when the Jumpmaster lifted their foot off the static line to allow recovery of the static line bag, the static line strong point cable unexpectedly detached and fell from the aircraft.

- While internal failure cannot be reliably detected by visual inspection alone, Jumpmasters and aircraft loaders should be reminded to conduct a positive visual and tactile check of accessible cable sections and connection points during setup.

- Static line cable and strong point visual inspection.
PTOs operating aircraft with ATLAS Aviation (or similar) static line systems should:
Ensure the static line cable and strong point are inspected and if any damage or wear is found then contact maintenance for further examination.

- Chief Instructors should brief their instructors:
The circumstances of this incident and the importance of a visual inspection of the static line strong point and cable before and during hooking up students. Paying particular attention to possible wear points (see image 1).
