## **Riggers' Subcommittee**

**Thursday 27 July 2017 at 1600**

**at BPA HQ, 5 Wharf Way, Glen Parva, Leicester LE2 9TF**

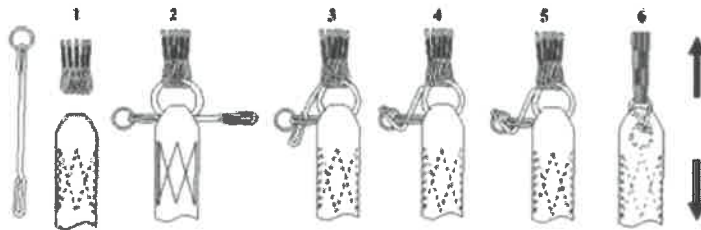
#### 2.2.1 Soft-links

Secure the Soft Link ring in the webbing pocket, and load tack as shown or as described in the reserve canopy instruction manual.

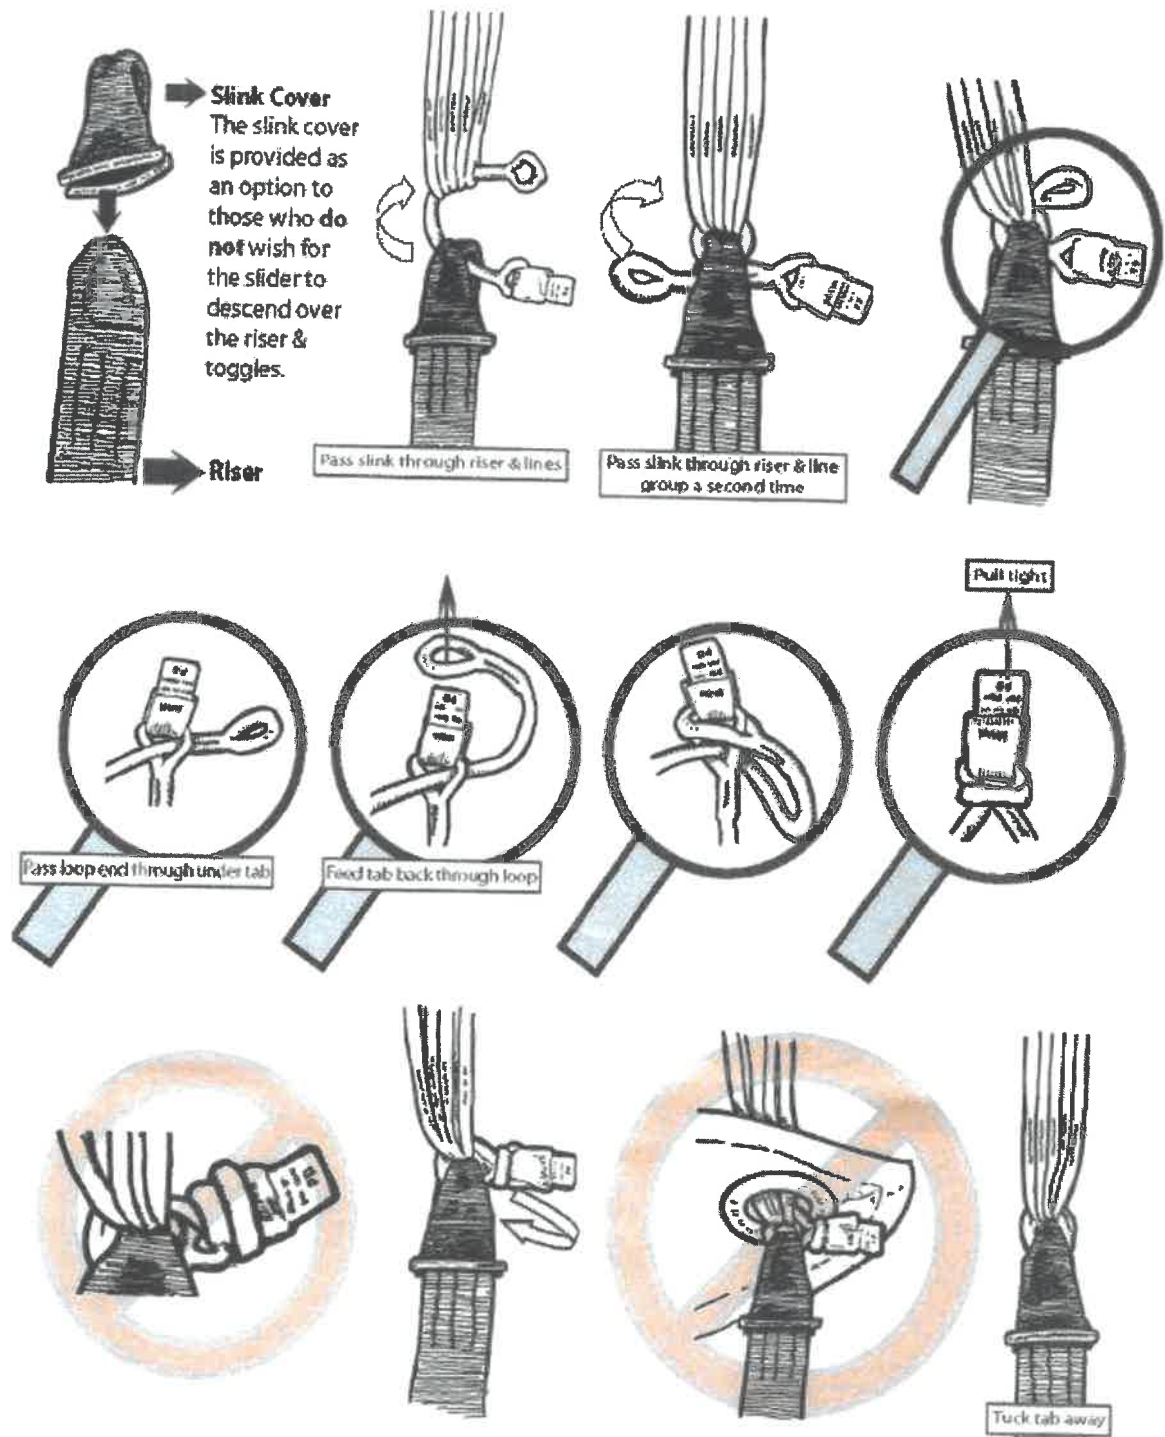
During the first 15-20 deployments on a set of slinks they will develop a "set". Make sure this set happens properly by keeping the Slink tab positioned inside the riser during these initial pack jobs/deployments.

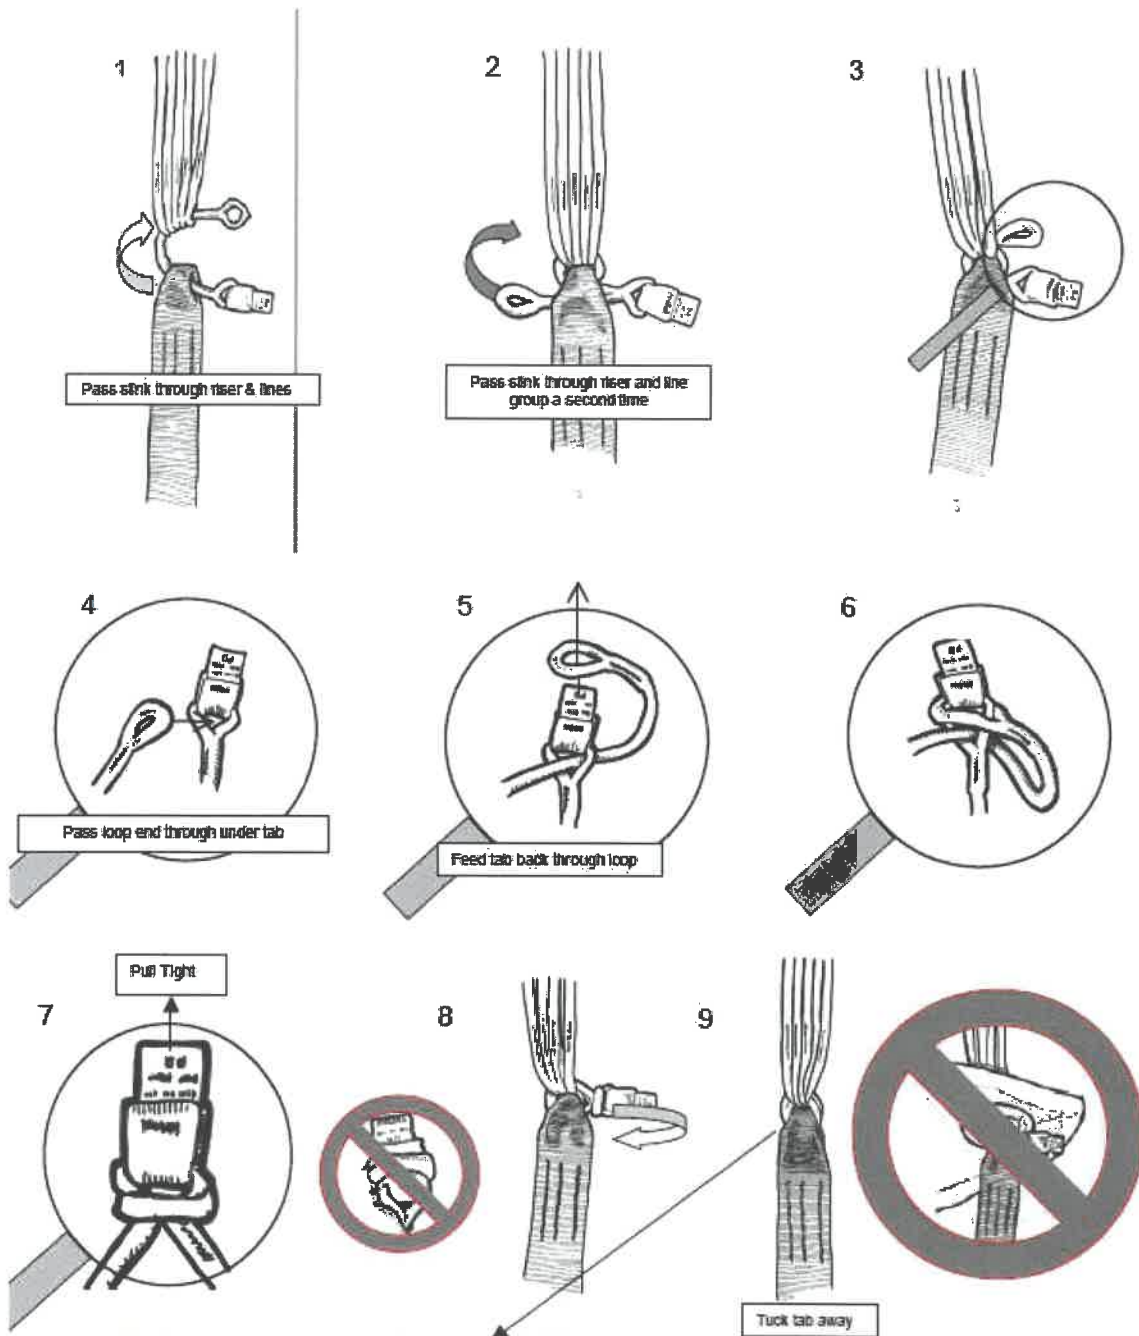
The first 15-20 deployments will cause the sink to take a more permanent "set". It is important to ensure that the tab is located between the riser during this period so as to insure this set occurs with the tab in the proper position. Once this has occurred, the sink will have a tendency to remain in this position. If this procedure is not followed, the tab may rotate out of position. Allowing the tab to remain outside of the riser during deployment and flight may result in excessive wear of the sink, potentially leading to a structural failure.

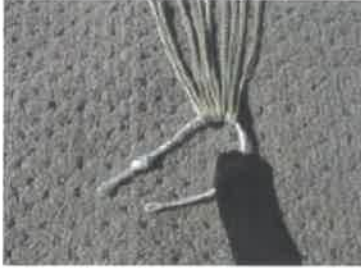
1) Check the continuity of your line group. Begin installation by inserting the link through all the lines and then through the riser.

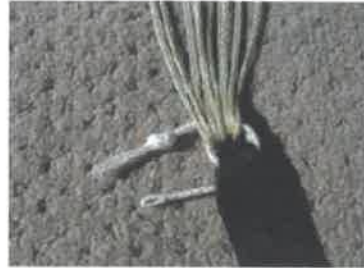
2) Pass the link through the lines and through the riser again, so that the link forms a doubled loop.

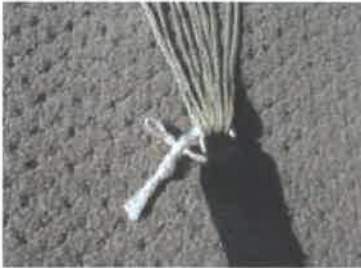
3) Insert the small loop at the top of the link through the loop just above the stopper knot. It may be necessary to use a fid or ballpoint pen to open the loop slightly to allow insertion.

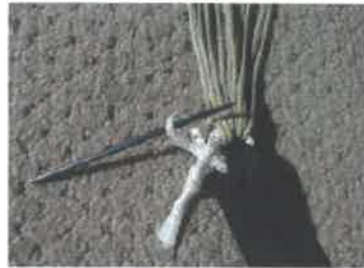
4) Using a fid, ballpoint pen, or similar object, carefully open the top loop a little wider to enable it to pass over the stopper knot. Make sure that you don't damage any of the fibers as you perform this step.

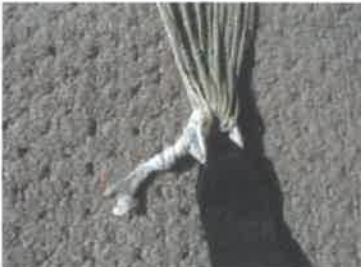
5) Now pass the widened loop over the stopper knot, then "milk" the finger-trapped portion of the link to return the top loop to its original smaller size.

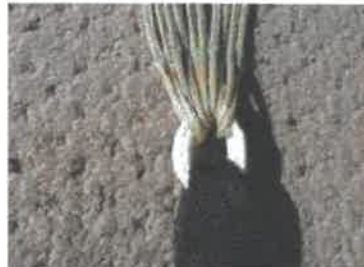
6) Rotate the link so that the knotted portion is hidden inside the riser. Finally, pull the riser and suspension lines away from each other to tighten the connector link. It is important that the locking section of the link remain inside the riser, so for the first several pack jobs check for this. After a few jumps the link will take a "set" and have no tendency to rotate.

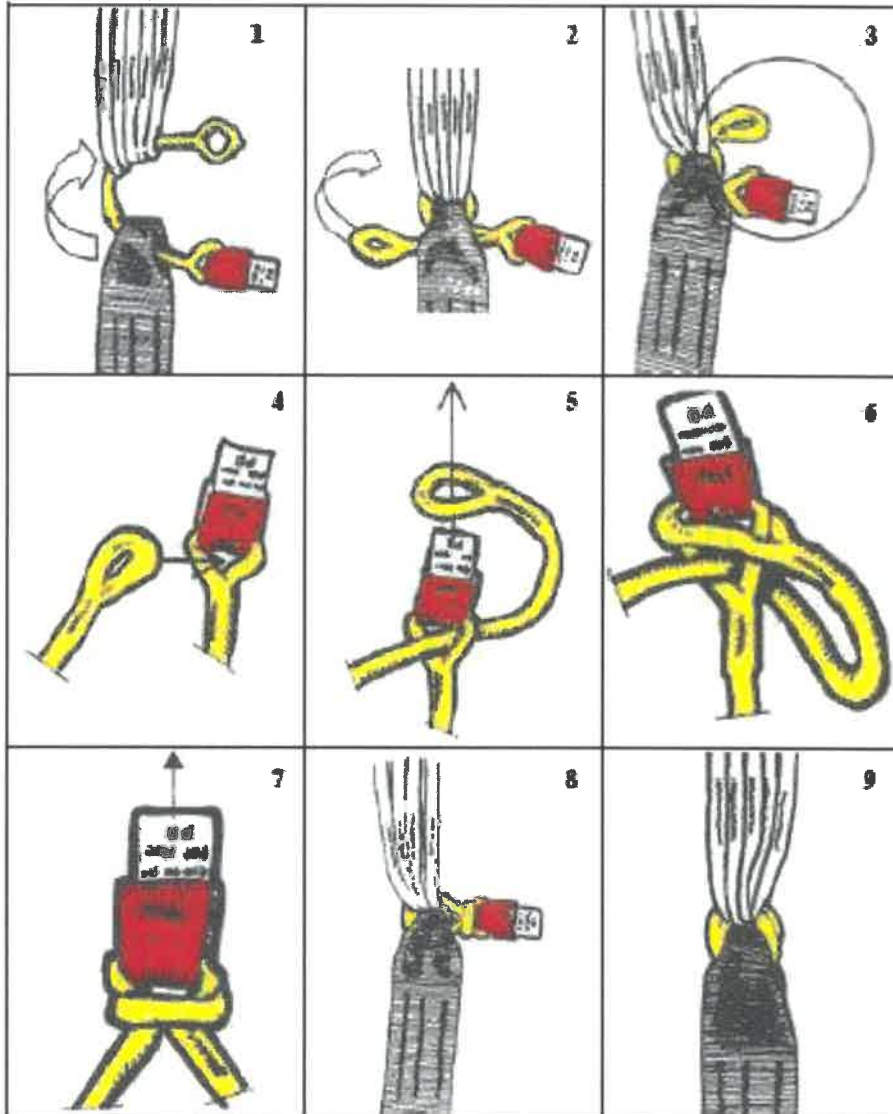
## How to mount Soft Links to your canopy:

It is important that the softlinks will stay in the right position. They should not turn out of the riser (like in picture 8). The red marked stopper must remain inside the riser. If the stopper is out of the riser it is possible to get caught a line. This can cause a malfunction on the main canopy. To avoid that it is possible to fix the softlink to the riser. (Use supertack 80-90 lbs. MIL-T-43435 or 50 lbs. MIL-T-43435).

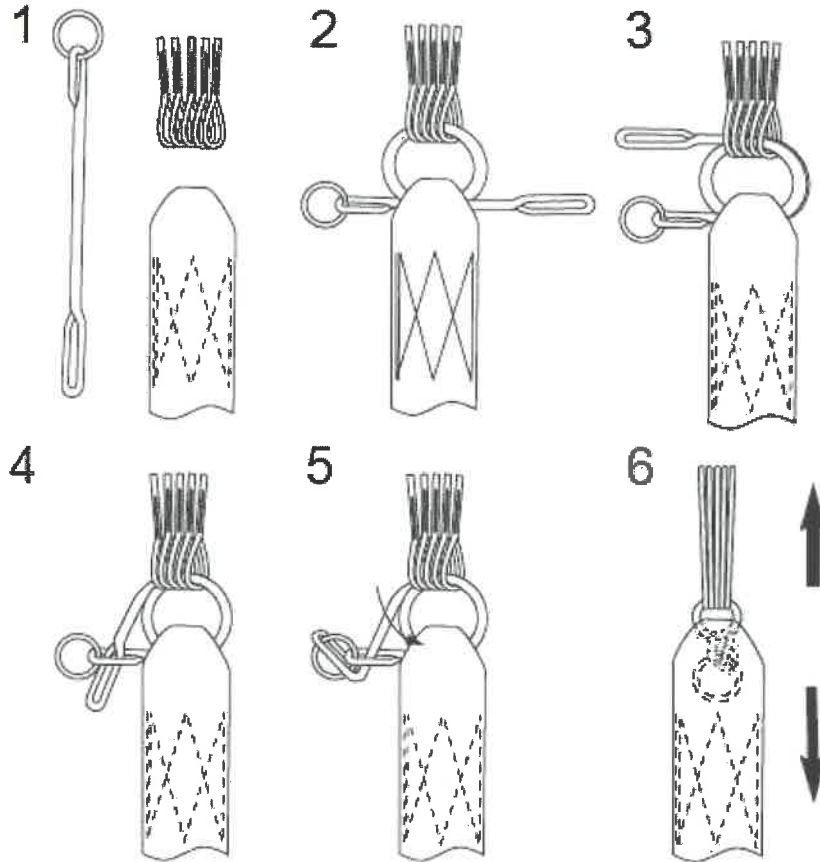
Installation procedure on front and rear risers:

If the canopy is connected to the risers with stainless steel rapid links, tighten the barrel with a wrench (do not over tighten or you may break the barrel) and slide the silicone tube over the link for protection.
